The A320 Habsheim accident

An Airbus Industrie response to allegations made in television programmes and other media

March 1991

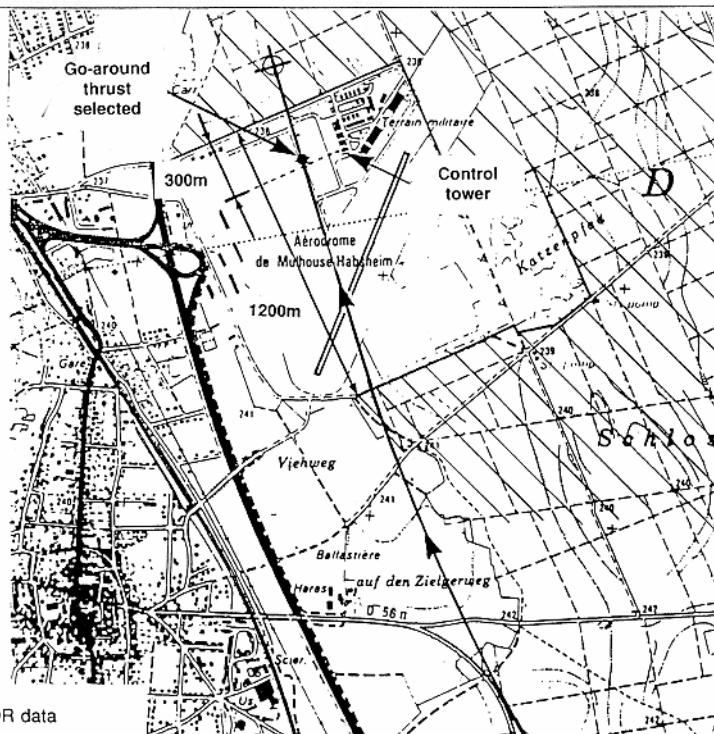
Flight path over Habsheim airfield

Reproduced by Airbus Industrie from DFDR data

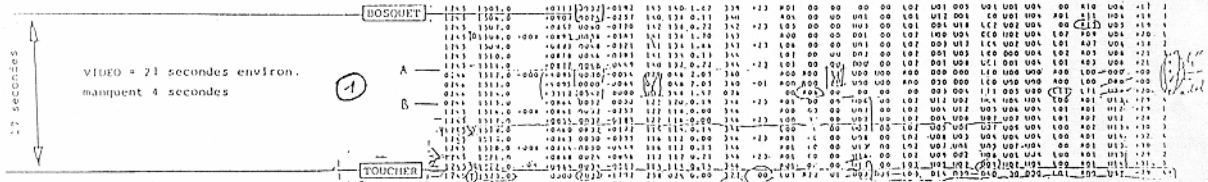
Extract from Final Report showing the unread seconds

- According to the accident report **this event, during the first reading of the tape, was caused by a fold in the tape and/or dust particles present during reading and caused the tape reader head to lose contact with the tape.** The tape was thus cleaned and smoothed and the subsequent readings, made at a lower speed, allowed recovery of all the parameters.

The DFDR provides a complete and fully coherent record of the entire flight through to a point 1 second after contact with the trees. The first reading of the tape failed to recover the available data for purely mechanical reasons. Subsequent readings provide all the data. The first listing is, in effect, only a working copy.

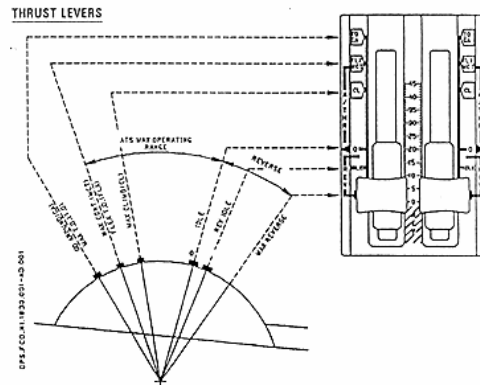
Extract from the CVR record

12 H 45'32"	F/O	Watch out for the pylons ahead eh see them ?		
12 H 45'33"	Capt	Yeah, Yeah don't worry		
12 H 45'34" 5/10				Clack I Clack I Clack I (power lever detents)
12 H 45'35" 3/10				"Thirty" (radio altimeter)
12 H 45'36" 2/10				"Thirty" (radio altimeter)
12 H 45'37"	F/O	TOGA/SRS		
12 H 45'38" 3/10				"Thirty" (radio altimeter)
12 H 45'39"	F/O	Go around track		Increase in engine speed. Noise of impact in the trees.
12 H 45'39" 9/10	Capt	Sh.....I		
12 H 45'41" 5/10		END OF TAPE

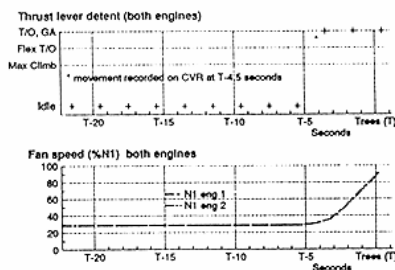
Extracts from the DFDR recordings

GMT	Tgen	Altitude feet	Air Speed	Thrust lever		Engine N1	
				eng 1	eng 2	eng 1	eng 2
1245	322.2	126	133 035	-030	133	029	029
1245	323.2	121				029	029
1245	324.2	+00012	120	029	029	-030	130
1245	325.2		126			029	029
1245	326.2		126	029	029	-030	130
1245	327.2		125			029	027
1245	328.2	+00012	122	029	029	-030	130
1245	329.2		123			029	029
1245	330.2		116	025	025	+064	+064
1245	331.2		116			026	026
1245	332.2	+00122	112	025	025	+064	+064
1245	333.2		112			027	027
1245	334.2		116	025	025	+064	+064
1245	335.2		113			026	026

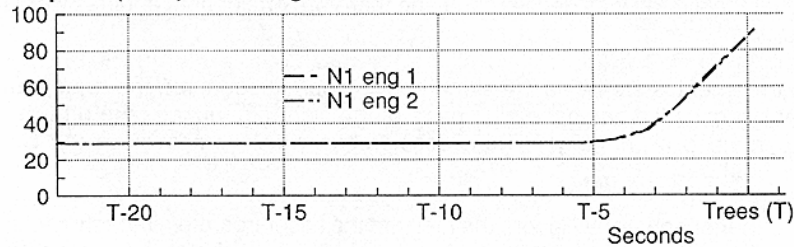
Fan speed (%N1) both engines

Having established that there is no evidence of either a compressor stall (see discussion concerning the CVR and the quoted "boom, boom" sounds) or that an engine failed to accelerate (previous page), it is appropriate to point out that a further piece of evidence leads to the conclusion that both engines operated in unison.

If either engine had failed to accelerate normally rudder deflection would have been required to maintain the flight path achieved

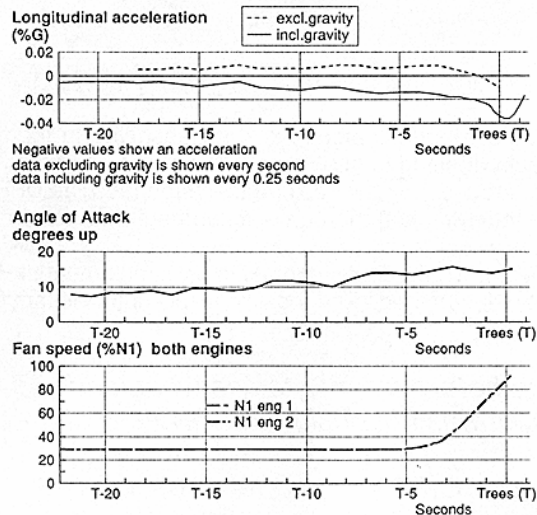
Extract from the DFDR transcript

The aircraft longitudinal acceleration (see page 55) includes the gravity component present due to the pitch attitude of the aircraft. Removing this gravity component shows that the aircraft was decelerating until the last few seconds when speed stabilised followed by an acceleration as the engine thrust increased but limited in time due to tree contact.

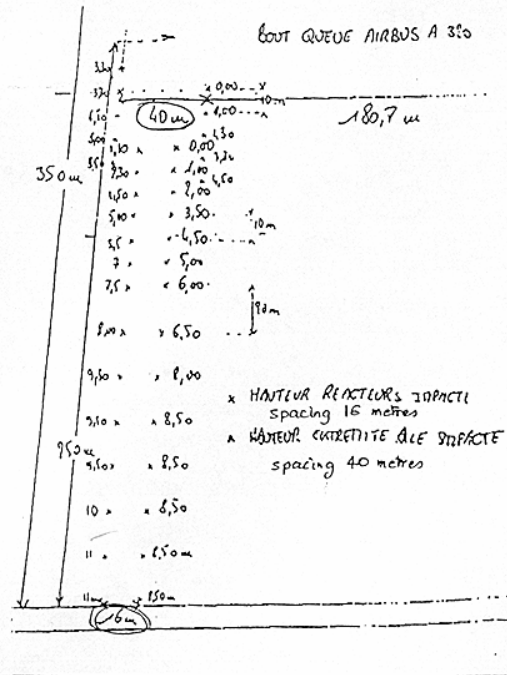
The tree cut heights

- Although the aircraft was at a low speed (for an aircraft in flight) the cutting of the trees occurred not only due to the jet efflux but also due to physical contact with the aircraft structure or engines. Indeed, the examination of the engines after the accident clearly shows a massive ingestion of leaves and branches into the core of the engine (i.e. near to the centre).
- The video clearly shows smoke plumes from both engines as the aircraft entered the trees and caused by ingestion of leaves. These plumes, contrary to the claim of one journalist, are of approximately the same size which suggests that similar thrust was being generated by both engines.

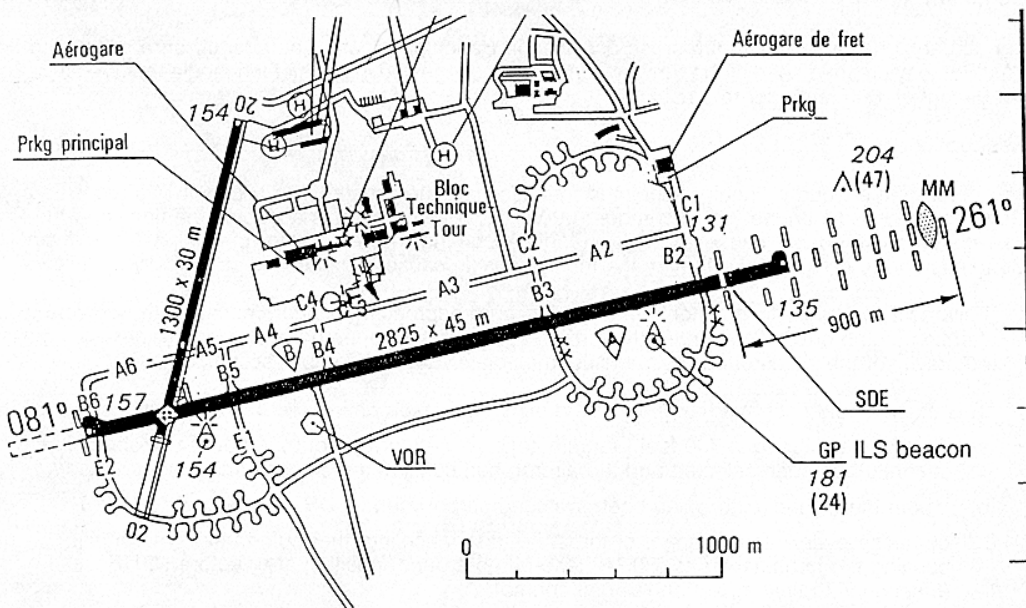
④ The site of the Lille incident

A320 made cat 3 landing on runway 26, touchdown close to taxiway B2 intersection
Light aircraft taxied off taxiway B3 onto runway 26
