FINAL
KNKT.14.12.29.04

Aircraft Accident Investigation Report

PT. Indonesia Air Asia
Airbus A320-216; PK-AXC
Karimata Strait
Coordinate 3°37'19"S - 109°42'41"E
Republic of Indonesia
28 December 2014

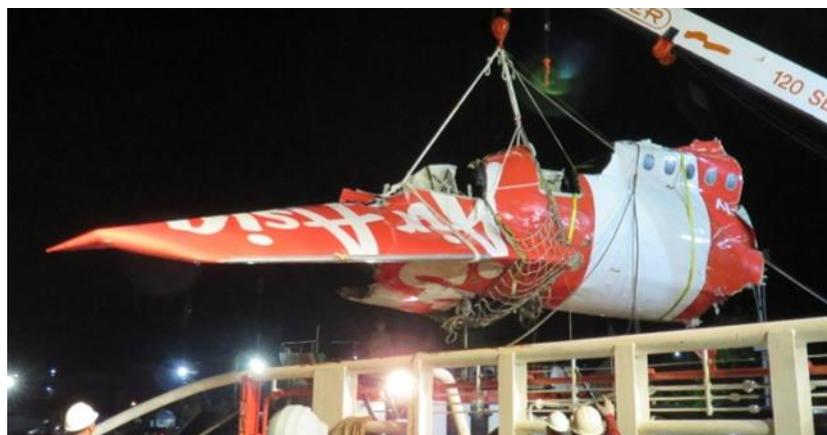
Figure 3: The recovered tail section being transferred to Kumai Harbour

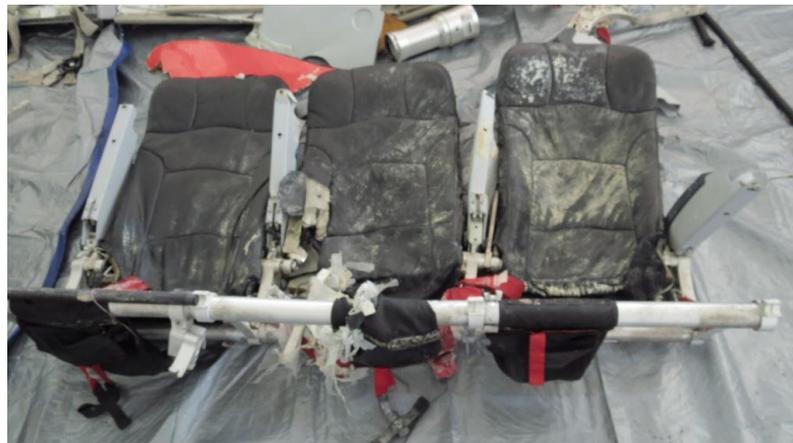
Figure 4: One section of passenger seats

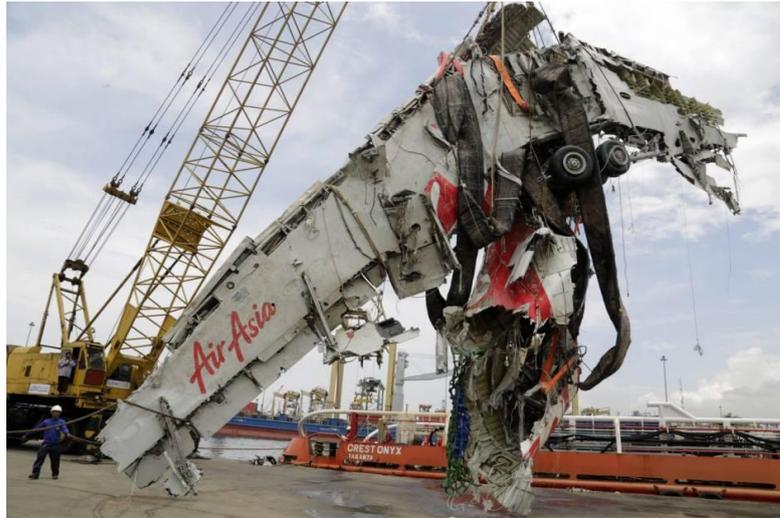
Figure 5: Centre fuselage section including the wings and main landing gears

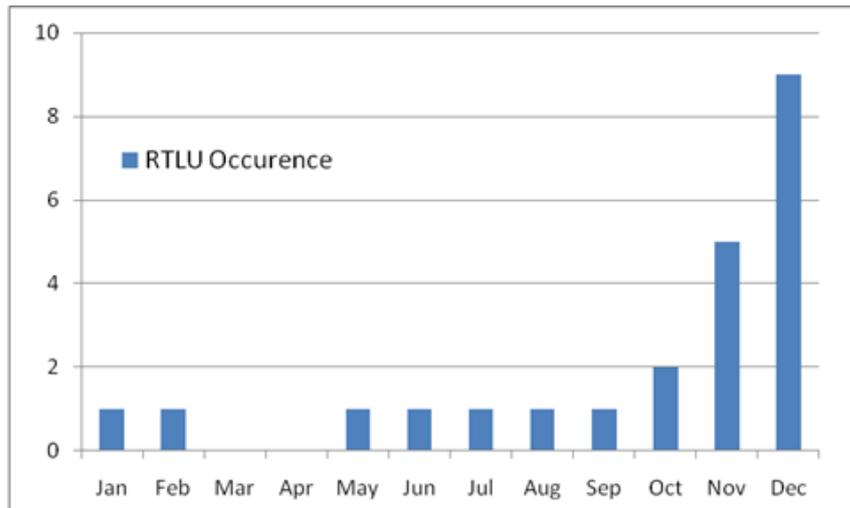
Evaluation of MR1 data, in November 2014 found 5 pilot reports related to RTLU problem on 10, 13, 20, 22 and 24 November 2014 and in December 2014 found 9 pilot reports related to RTLU problem on 1, 12, 14, 19,21, 24, 25 (two cases), and 27 December 2014.

Figure 7: Numbers of the RTLU Occurrences in 2014

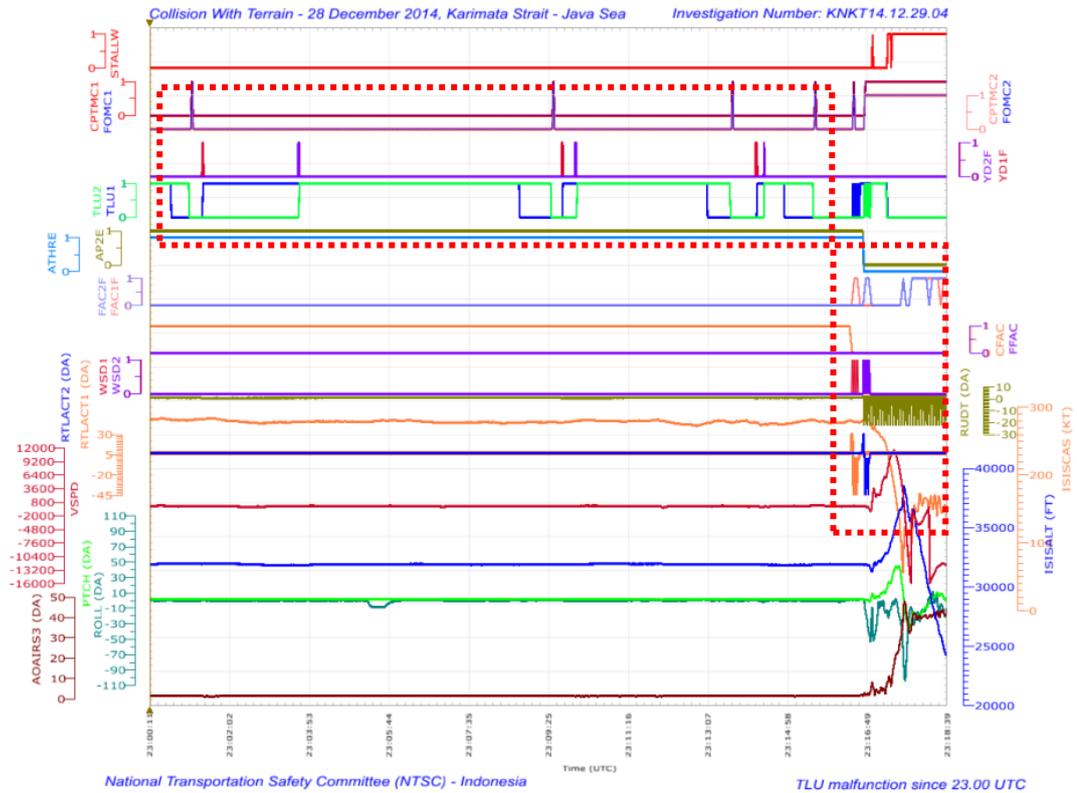
Figure 20: RTLU problems and pilot actions

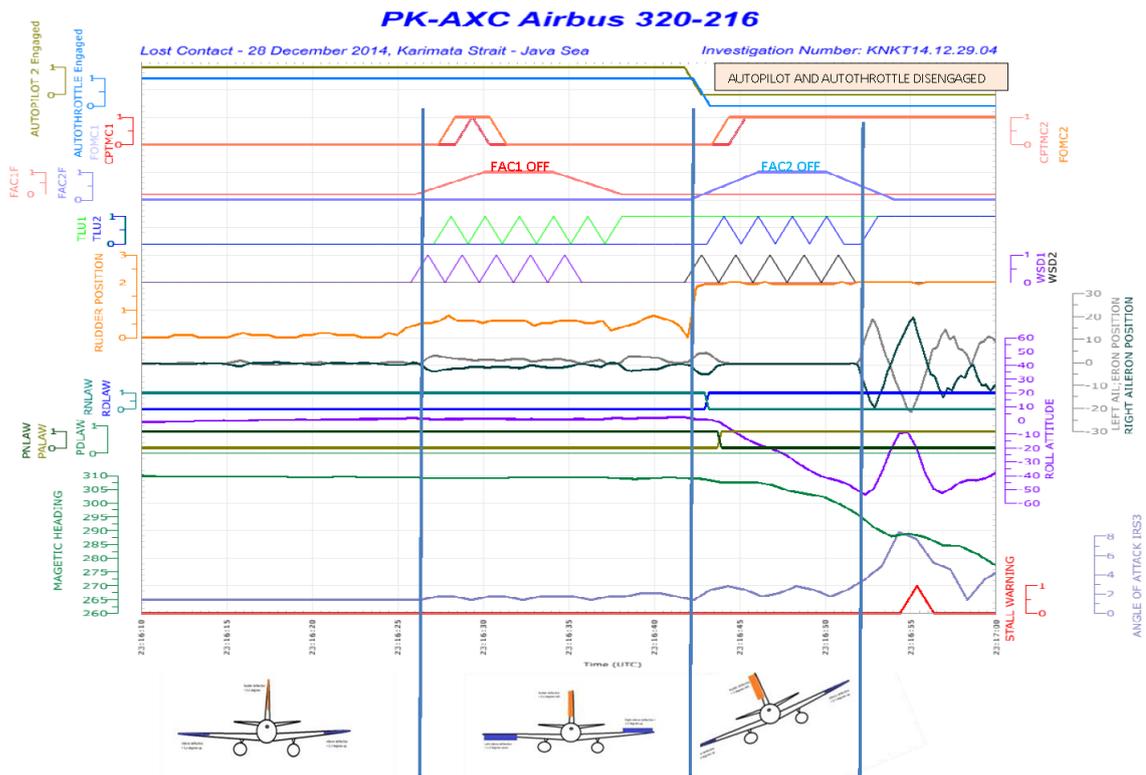
The fifth Master Caution at 2316:28 UTC was triggered by FAC 1 FAULT.

Figure 21: FDR parameters after the fifth Master Caution

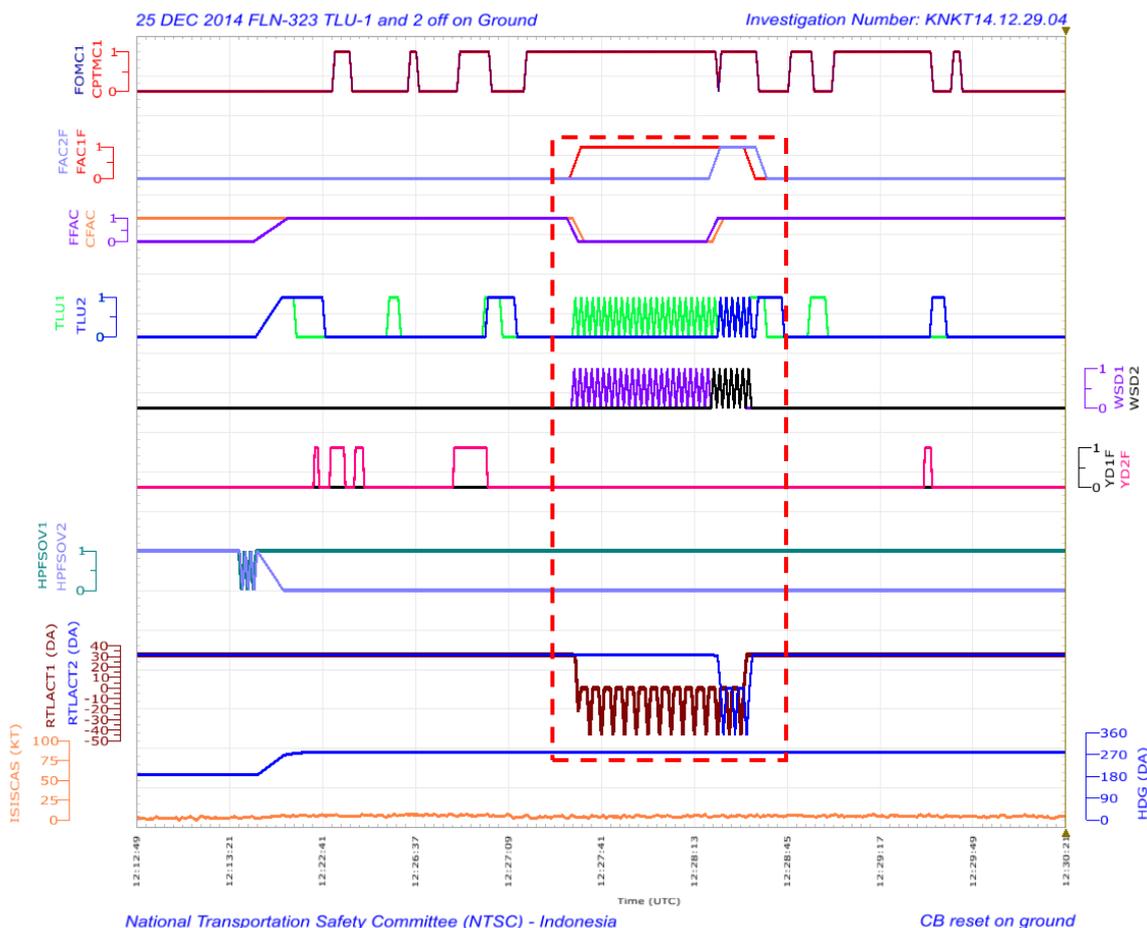
Figure 24: The FDR parameters of FAC fault followed by CB reset on the ground at 25 December 2014

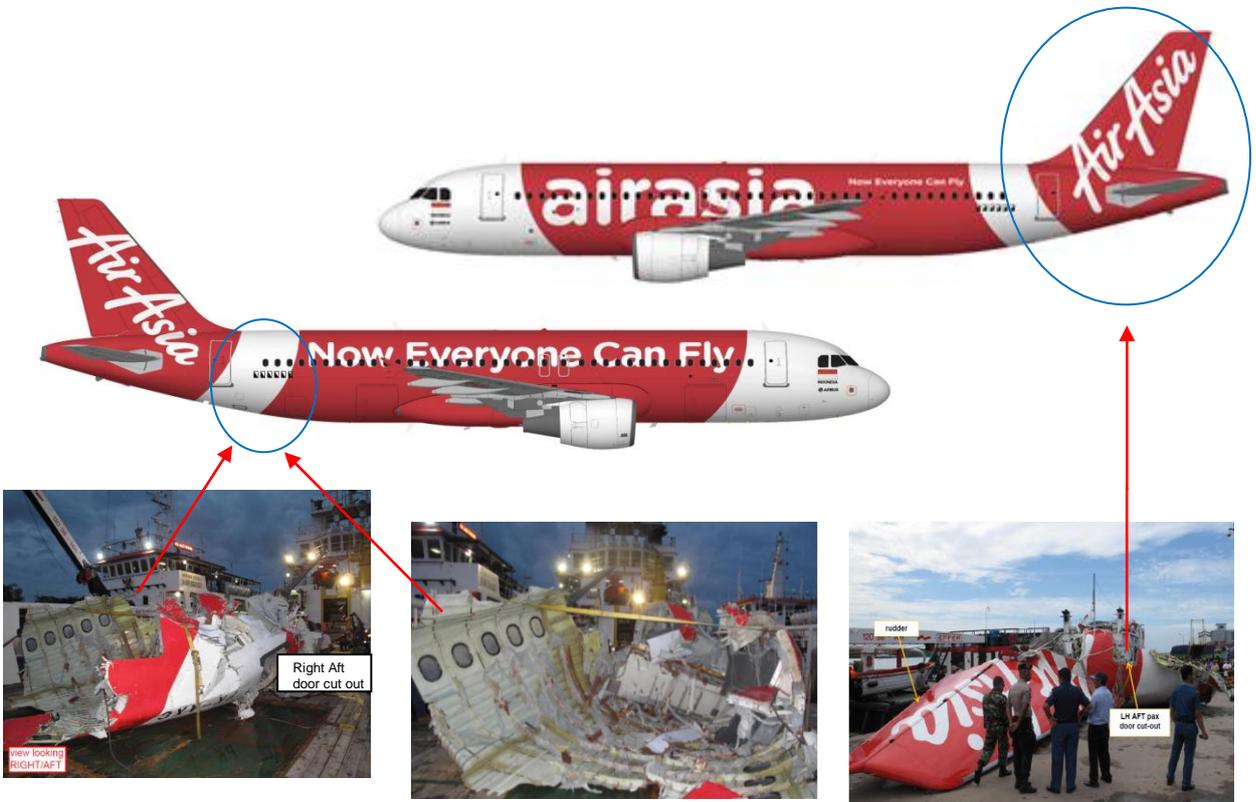
Figure 32: Pictures of identified parts and its original position

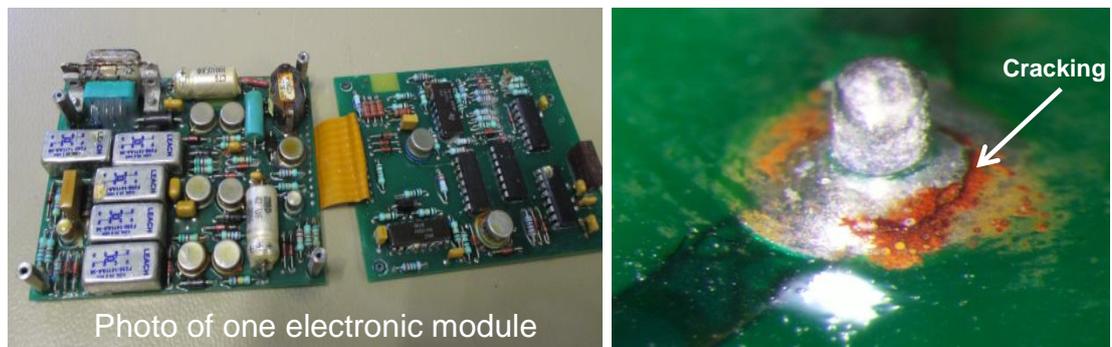
- The cracking of a solder joint of both channel A and B resulted in loss of electrical continuity and led to RTLU failure.
- The existing maintenance data analysis led to unresolved repetitive faults occurring with shorter intervals. The same fault occurred 4 times during the flight.

Figure 35: Electronic Module of RTLUs
