FINAL
KNKT.14.12.29.04

Aircraft Accident Investigation Report

PT. Indonesia Air Asia
Airbus A320-216; PK-AXC
Karimata Strait
Coordinate 3°37'19"S - 109°42'41"E
Republic of Indonesia
28 December 2014

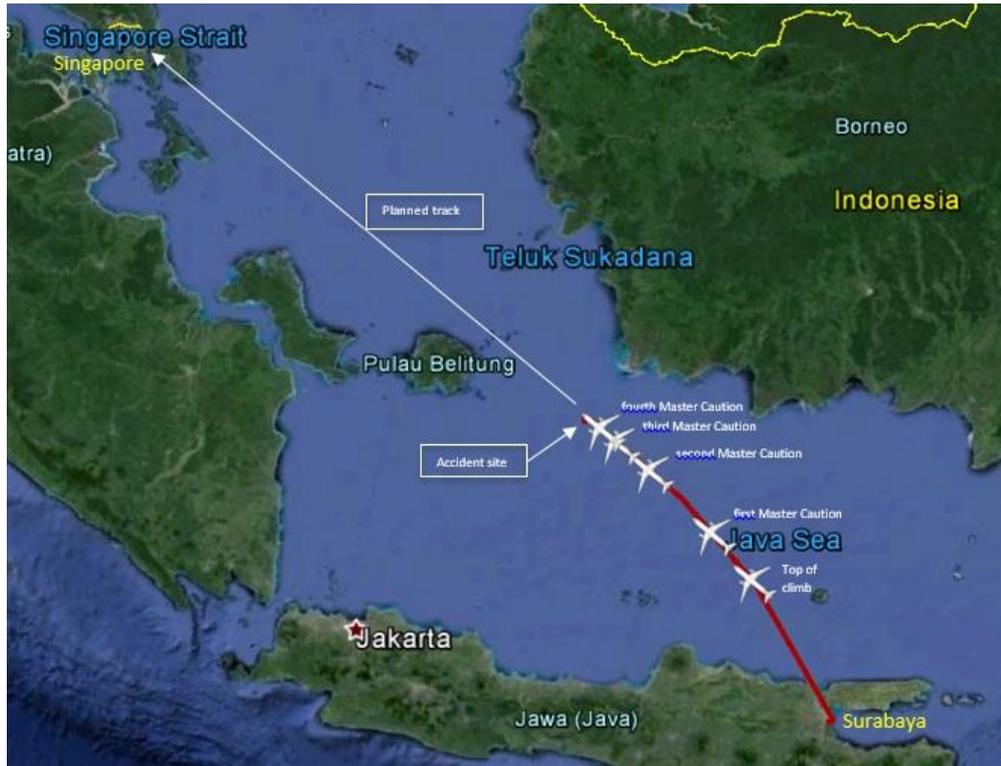
Figure 2: The aircraft flight track

At approximately 29,000 feet the aircraft attitude was wings level with pitch and roll angles of approximately zero with the airspeed varied between 100 and 160 knots. The Angle of Attack (AOA)⁵ was almost constant at approximately 40° up and the stall warning continued until the end of recording. The aircraft then lost altitude with an average rate of 12,000 feet per minute until the end of the recording.

At 2318 UTC, the aircraft disappeared from the Jakarta Radar controller screen. The aircraft last position according to the Automatic Dependent Surveillance-Broadcasting (ADS-B) radar was on coordinate 3°36'48.36"S - 109°41'50.47"E and the aircraft altitude was approximately 24,000 feet.

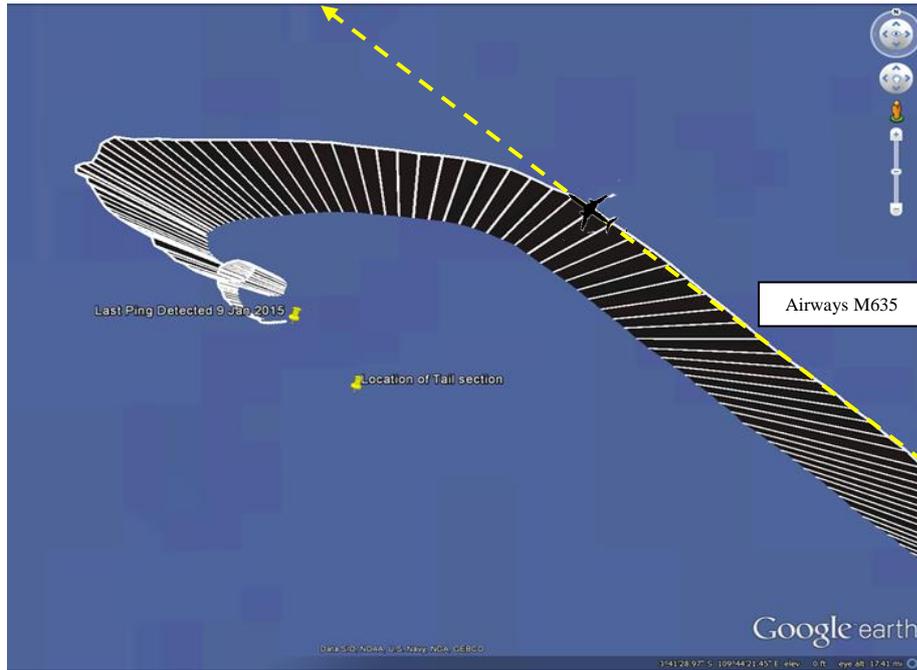
Figure 19: Flight path based on FDR data superimposed to the Google Earth

The FDR data showed that while the aircraft was cruising at an altitude of 32,000 feet in normal condition, the aircraft then deviated to the left from airway M635. The master caution triggered by both RTLU problems activated 4 times. The fifth master caution was related to the FAC 1 FAULT activating. The sixth master caution was triggered by the FAC 1+2 FAULT and followed by the autopilot and auto-thrust disengaged and flight control law reverted from Normal Law to Alternate Law.

Subsequently the aircraft entered a steep turn and climb, eventually reaching high angle of attack, the stall warning activated and continued until the end of the recording. The FDR and CVR recording ended at 2320:35 UTC.

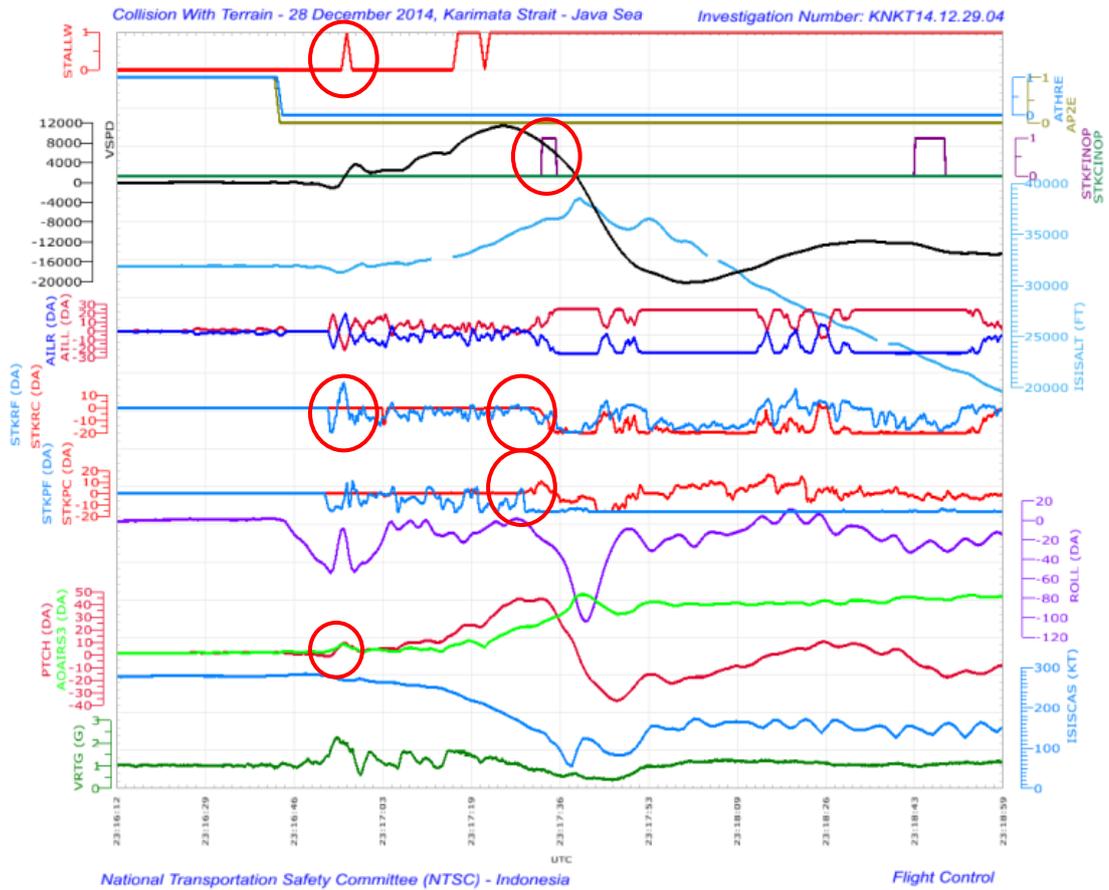
Figure 22: Pilots inputs on side stick

- o Flight control law reverted from Normal Law to Alternate Law
 - o Rudder deflected 2° and aileron deflection 0°.
- The aircraft started to roll.
- At 2316:54 UTC the FAC 2 was back to ON and all fluctuating parameters stopped. The autopilot and auto thrust remained disengaged. Flight control law remained in Alternate Law.

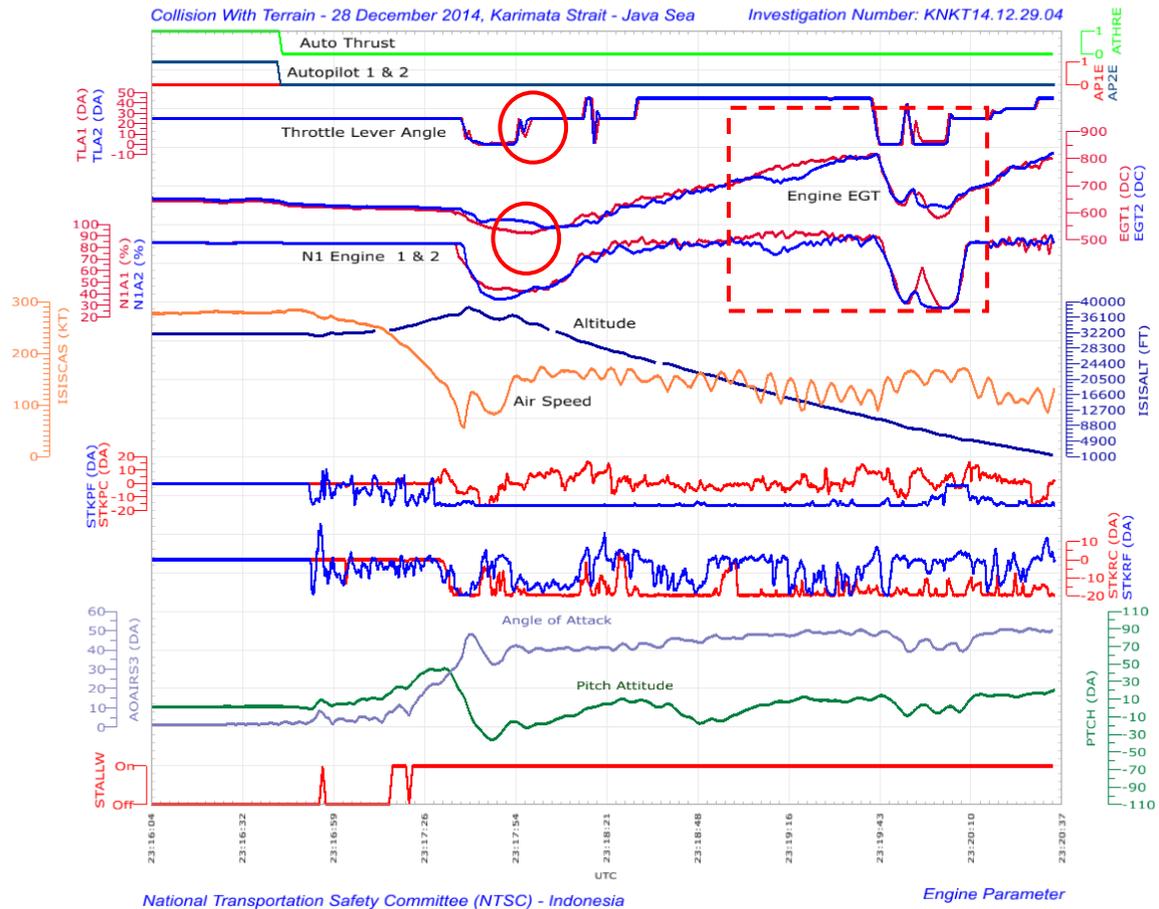
Figure 23: Thrust levers and side-sticks movement

- At 2317:41 UTC the aircraft reached the highest altitude of 38,500 feet (ISIS) and largest roll angle at 104° to the left. The aircraft then descended with a rate up to 20,000 feet per minute momentarily afterward the rate of descent was recorded at average of 12,000 feet per minute until the end of recording.

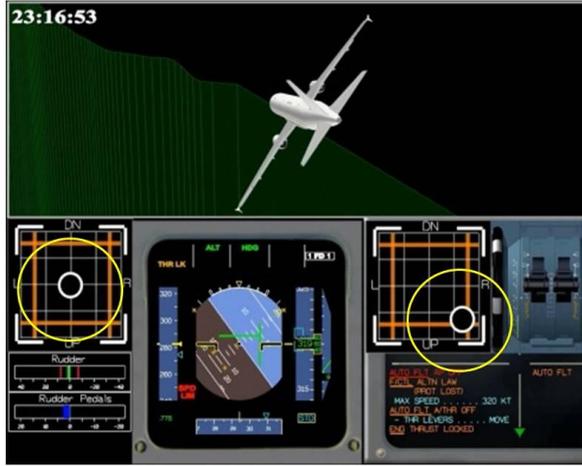
Figure 25: Aircraft rolled 54° to the left

Speed (knots)	277 (ISIS)	282 (CAS)
Alt (feet)	31952	
Rudder	2°	
Roll	54°	
Pitch	-1.1°	
AOA	3.5°	
VS(fpm)	-1088	
N1	83%	
EGT	622 °C	
Sidesticks	PIC P: 0° R: 0°	SIC P: -15° R: +19

Time (UTC)	From	To	Description
23:16:43	Warning		Auto pilot disengaged followed by cavalry charge (autopilot disengaged warning)
23:16:53	P1		“Oh my God”
23:16:54			The FAC 2 was re-energized
23:16:56	Warning		Stall warning activated for 1 second

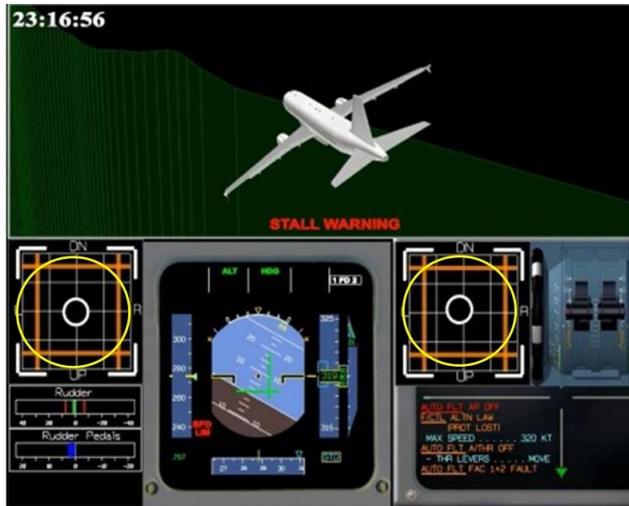
Figure 26: The first aural Stall warning activated

Speed (Knots)	268 (ISIS)	272 (CAS)
Altitude (Feet)	31980 (ISIS)	33900 (GPS)
Rudder	2°	
Roll	19.7°	
Pitch	9.5°	
AOA	8°	
VS (fpm)	2624	
N1	83%	
EGT	621 °C	
Side-sticks	PIC P: 0° R: 0°	SIC P: 7° R: +10°

Time (UTC)	From	To	Description
2317:02	P1		Gave instruction “level...level...level...” (4 times)
2317:15	P1		Gave instruction “pull down...pull down” (2 times)

2317:17	Warning		Aural stall warning announced with cricket sound. Change of external airflow sound.
2317:22	P1	P2	Gave instruction “pull down...pull down” (3 times)

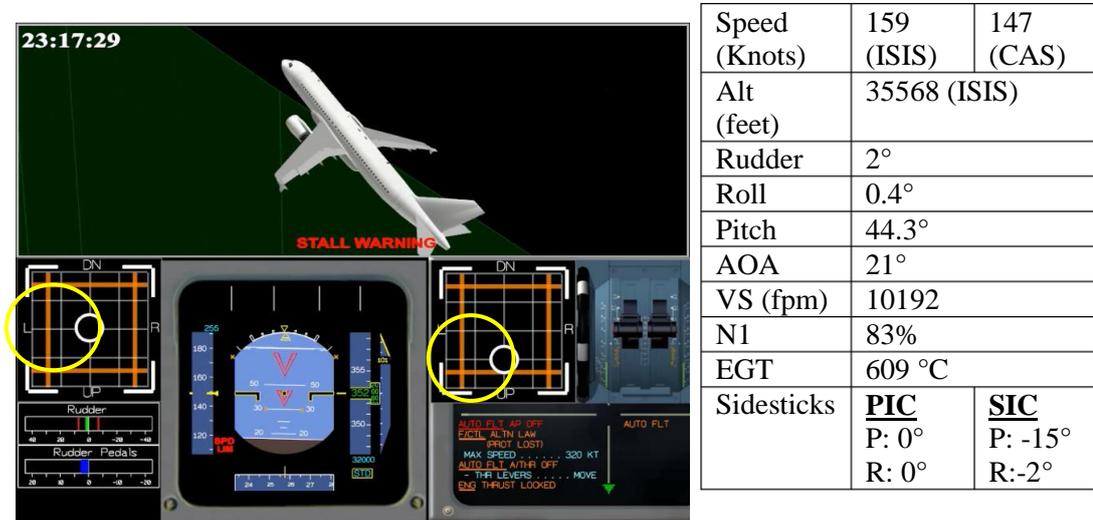
Figure 27: The aircraft attitude at the highest pitch angle

Time (UTC)	From	To	Description
2317:23	Warning		Aural stall warning activated with cricket sound and a sound similar to aircraft buffet continued until the end of recording.
2317:25	P1		Gave instruction “pull down...pull down”
2317:29	P2		<i>in French</i> : “What is going wrong”
			The left side stick input continued until the end of recording. Dual input on the side sticks continued until the end of recording.

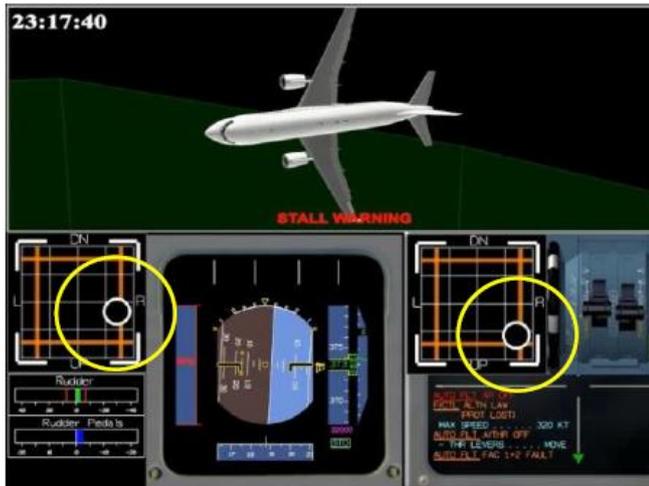
Figure 28: Aircraft in upset¹³situation

Speed (knots)	118 (ISIS)	0 (CAS)
Alt (Feet)	37796 (ISIS)	
Rudder	-5°	
Roll	-104 °	
Pitch	-20.7°	
AOA	46°	
VS (fpm)	-4784	
N1	52%	
EGT	563 °C	
Sidesticks	PIC P: -4° R: -20°	SIC P: -16° R: -17°

Time (UTC)	From	To	Description
2317:41	P1		“My God.”

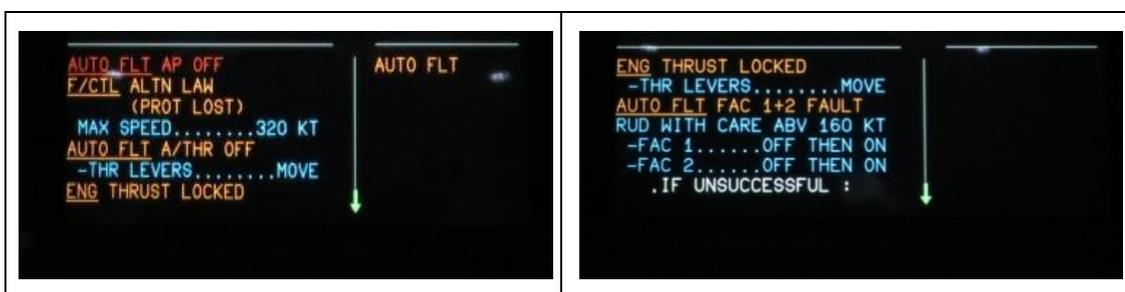
Figure 33: The page 1 and 2 of the ECAM messages after CBs of FAC 1 and 2 being reset

- Similar ECAM messages to the data recorded on the FDR appeared when the FAC CBs were pulled.
- Dual input resulted in rapid movement of the aircraft compared to single input
- Dual input in different direction of the side-sticks reduced the ability to control the aircraft.
- The Emergency Cancel Button was effective to prevent pilot distraction for a repetitive malfunction.

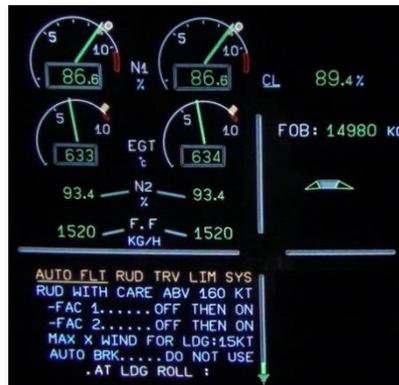
Figure 34: The ECAM messages after RTLTLU 1 and 2 fault

As requested by the KNKT, BEA and Airbus performed the simulator session which referred to FDR data on the engineering simulator. The simulation intended to recreate ECAM messages appeared on the accident flight. The ECAM message during the RUD TRIM LIM SYS problem is presented in the following figure:
